**Flood Control Project Maintenance
Levee Inspections**

2013 Channel Summary Report

Placer County

Truckee River

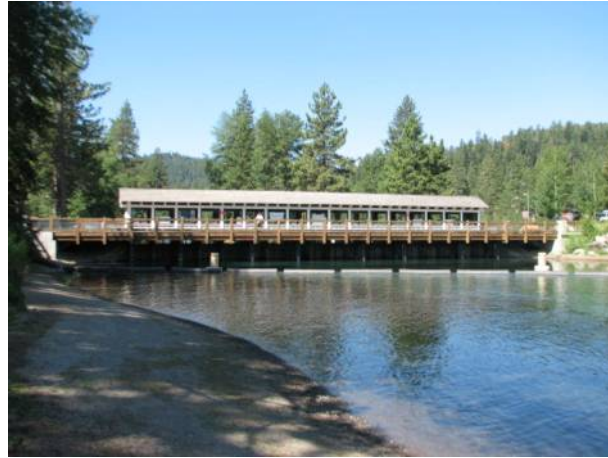
Levee Mile Report Line	1
Start Levee Mile	0.00
End Levee Mile	0.00
Location	
Category	Channels
Item	Vegetation & Obstructions
From the edge of Lake Tahoe looking at the structure. Summer 2013	
johngw_c_20130725_075.JPG

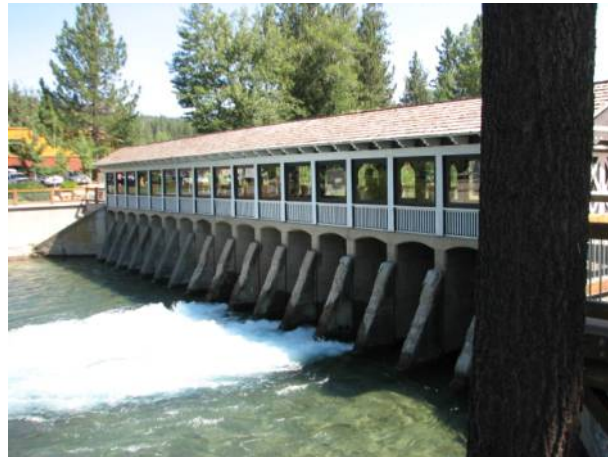
Levee Mile Report Line	6
Start Levee Mile	0.00
End Levee Mile	0.00
Location	
Category	Channels
Item	Vegetation & Obstructions
A side view of the downstream side of the structure. Summer 2013	
johngw_c_20130725_076.JPG

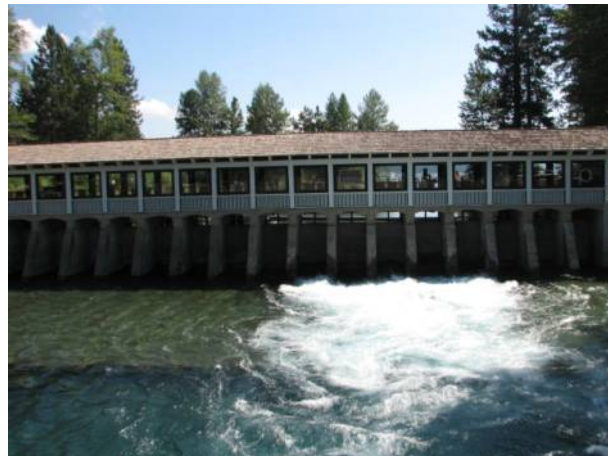
Levee Mile Report Line	11
Start Levee Mile	0.00
End Levee Mile	0.00
Location	
Category	Channels
Item	Vegetation & Obstructions
From Highway 89 looking at the outlet structure. Summer 2013	
johngw_c_20130725_077.JPG

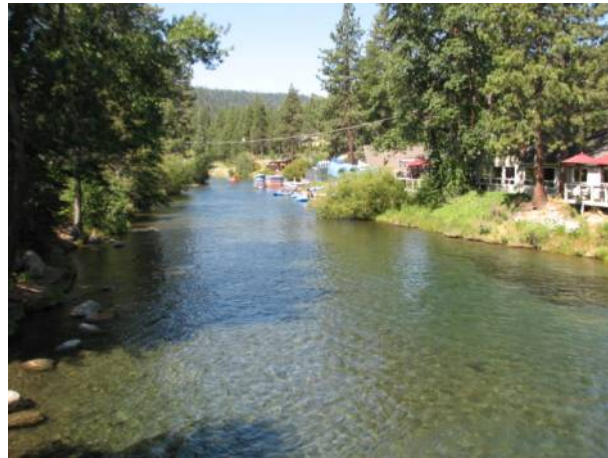
Levee Mile Report Line	16
Start Levee Mile	0.00
End Levee Mile	0.00
Location	
Category	Channels
Item	Vegetation & Obstructions
Downstream of the Truckee River from Highway 89. Summer 2013	
johngw_c_20130725_078.JPG

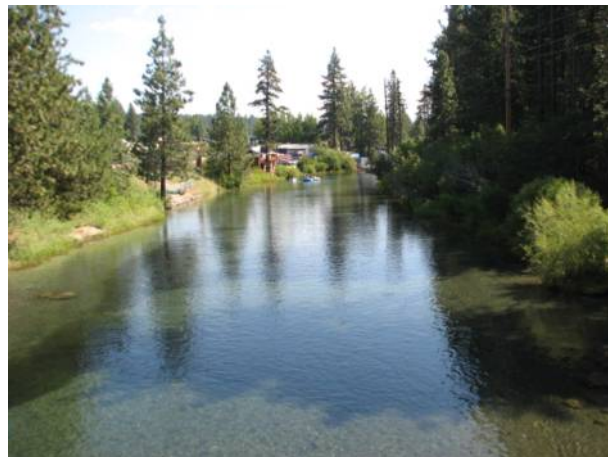
Levee Mile Report Line	21
Start Levee Mile	0.00
End Levee Mile	0.00
Location	
Category	Channels
Item	Vegetation & Obstructions
A upstream look of the Truckee River. Summer 2013	
johngw_c_20130725_079.JPG

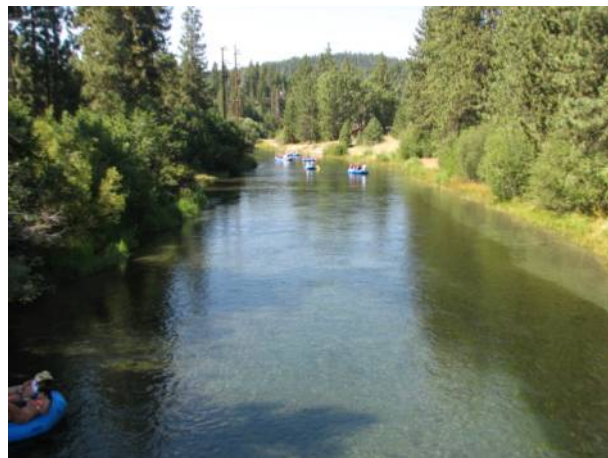
Levee Mile Report Line	26
Start Levee Mile	0.00
End Levee Mile	0.00
Location	
Category	Channels
Item	Vegetation & Obstructions
A downstream look of the Truckee River. Rafters are having fun. Summer 2013	
johngw_c_20130725_080.JPG

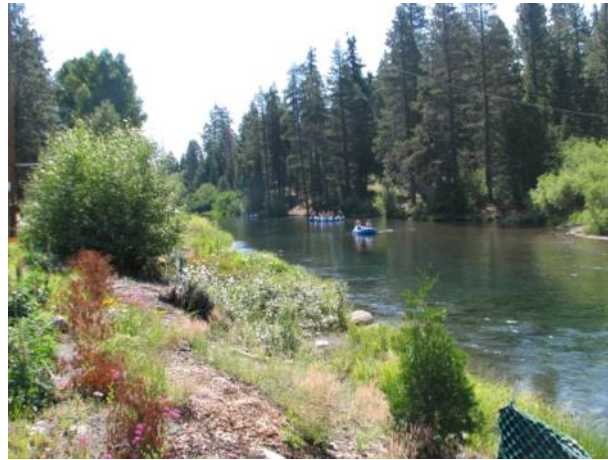
johngw_c_20130725_081.JPG

Looking upstream from Tahoe City Lumber Yard. Summer 2013

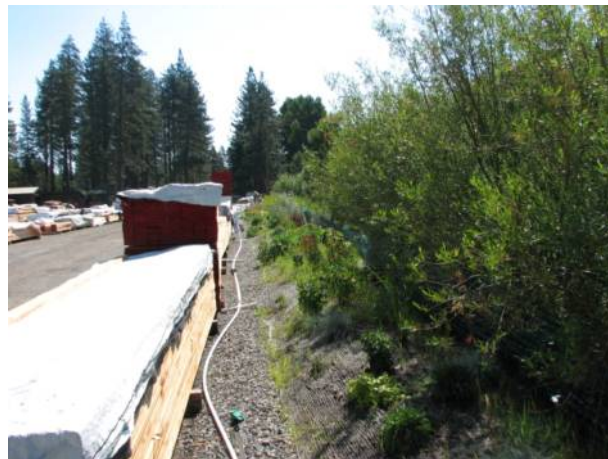
johngw_c_20130725_082.JPG

Looking at the landside of the berm built by the lumber yard, Summer 2013

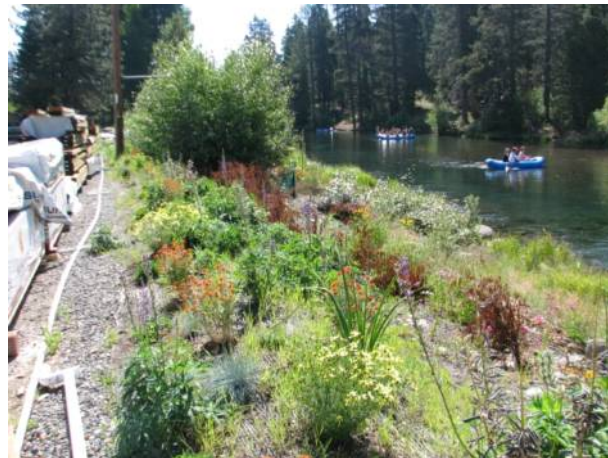
johngw_c_20130725_083.JPG

The vegetation on the berm has grown protecting the embankment. Summer 2013

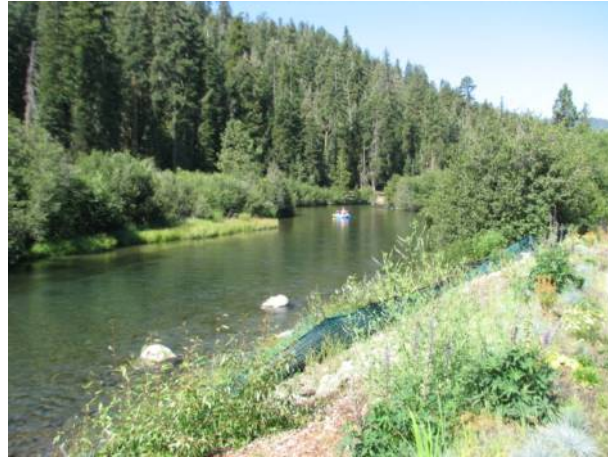
Levee Mile Report Line	36
Start Levee Mile	0.00
End Levee Mile	0.00
Location	
Category	Channels
Item	Vegetation & Obstructions
Looking downstream from Tahoe City Lumber Yard. Summer 2013	
johngw_c_20130725_084.JPG
